# Beadnell Lime Kilns

Following a partial collapse and growing concerns over the safety and dangers of these iconic structures, repairs were desperately needed.

Three lime kilns, the earliest built in 1789, are located east of Beadnell Harbour. By 1822, the kilns had fallen out of use. Limestone was burnt to make lime and then sent to Scotland from the harbour. Today, they are used by local fishermen to store lobster pots, are classified as Grade II Listed Buildings, and reside under the care of The National Trust.

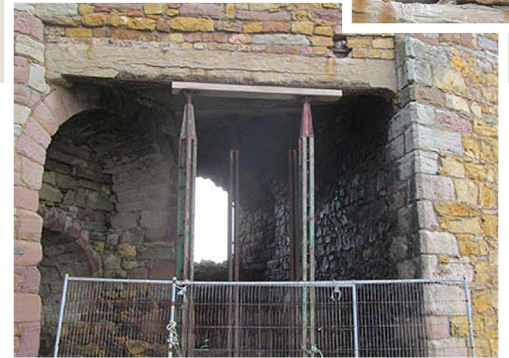
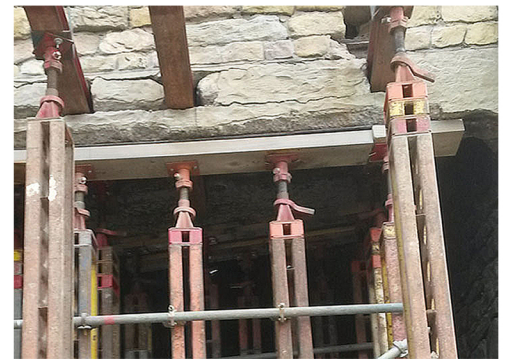
Previous repair works (of an unknown date) had been carried out to the kiln, which involved the installation of reinforced concrete beams and a concrete slab ceiling, to the front section of the tunnel (adjacent, right).

The concrete is reinforced with steel beams, some of which very close to the surface and had rusted causing the concrete to spall. Concerns over public safety resulted in the main beam and the concrete slab being propped up and the area fenced off (upper, right). However concerns persisted and grew, over the state of the rusting props with action needed to follow, to save the kilns from further collapse.

The old concrete lintel and rusting steel sections were removed and three new stainless-steel beams (painted to blend in) were put in place to fully support the kilns. This type of repair is classed as an 'Honest Repair' as it does not conceal or falsify the work.

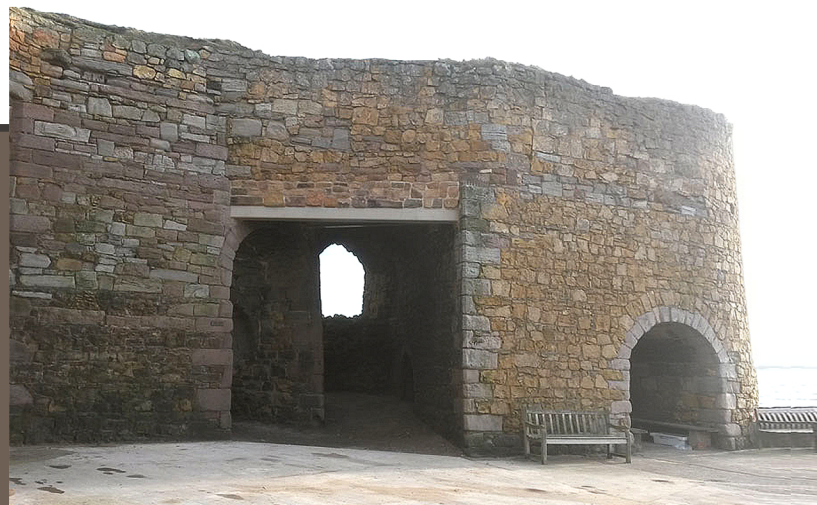
Structural interventions aside, we repointed the worst areas of the kiln walls (mortar in some cases had completely washed out), pinned and galletted to stones and fitted new oak doors and panelling, to create a fisherman's store within one of the drawing arches. The finished work to the lime kilns can be seen opposite.

This is now an area that you can walk under *with confidence*.
