# The Black Barn

This last known example of an original heather thatched roof in England had suffered severe and prolonged exposure to the elements.

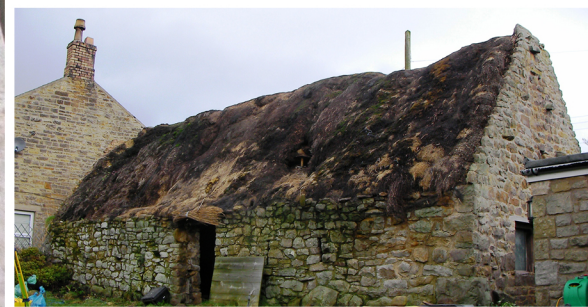
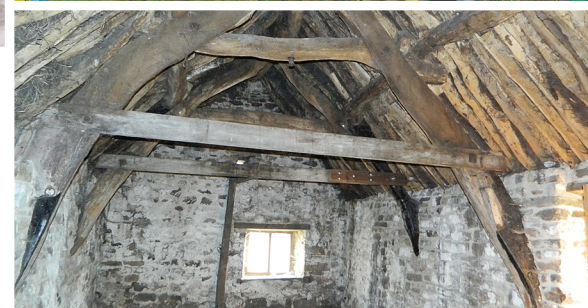
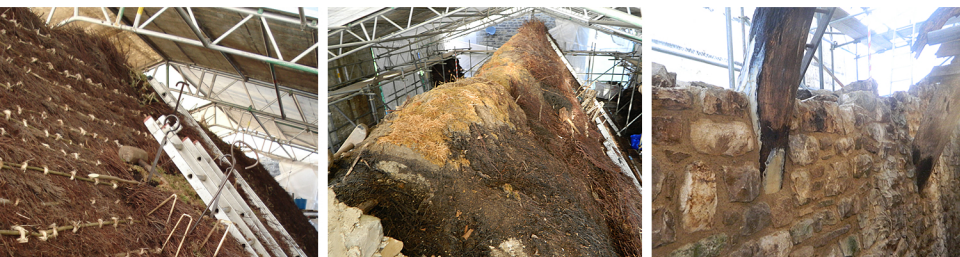
Most of the South-West slope of the roof had either been torn off by winds or degenerated into peaty compost. This also contributed to decay and loss of timber in the cruck frame, most of the oak rafters in that slope were ready to collapse. On the North-East, sheltered side much of the base coat of original heather thatching had survived along with some of the original rafters.

Following the erection of scaffolding and a temporary roof (so all repairs could be completed under cover), masonry consolidation and timber repairs were carried out using axe and augur for shaping & pegging rafters over the purlins. The only metal introduced was the use of new steel bolts were installed into the original timber to strengthen joints between the cruck blades and collars.

Opening up the feet of the cruck blades hidden in the walls revealed extensive rot. This was carefully cut out in-situ and extensions were built up in epoxy resin, reinforced with stainless steel rods.

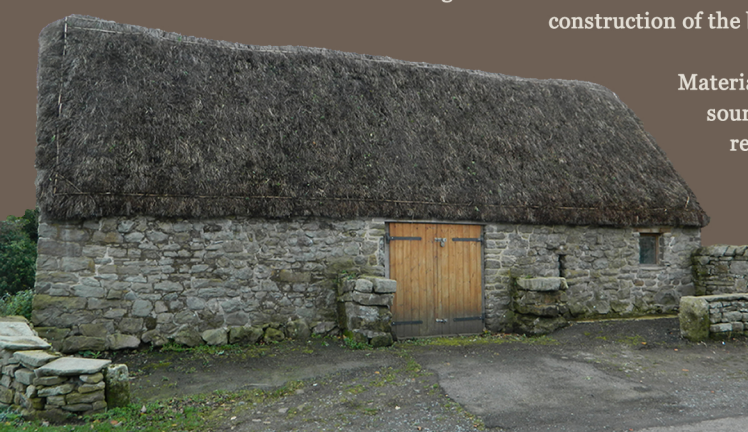
The barn is now fully restored (left).
