BRENDAN TEASDALE MASONRY CONSERVATION LTD

# Lindisfarne Priory

Lindisfarne Priory's powdery surface was evidence of stone decay, caused by harmful salts, preventing water evaporation and causing the stones to rupture and break down.

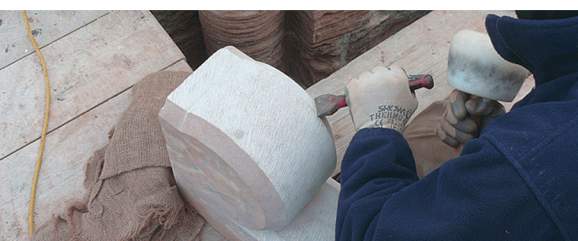
Where stone decay is evident within historic masonry fabric, this has often been caused by harmful salts within the structure. In many cases, harmful salts are the main contributor to stone decay, salt is soluble, and stone is porous. Salt laden moisture enters the pour structure within the stones where it is deposited, when these harmful salts dry out, they crystallise and expand. Over time this action slowly breaks down the structure of the stone. Cement over pointing will further limit the water evaporation and harmful salts from the stone therefore accelerated decay is usually inevitable. This type of decay is often found in the form of blistering or a friable powdery surface on the face of the stones.

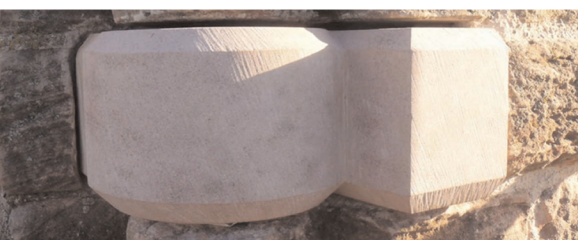
Moisture must be able to drain from the stones and cement mortars are too hard (in general) to allow this, thus, should never be used on historic building fabric. The use of traditional slaked lime mortars is very important on historic structures. The lime mortar should be weaker or more porous than the surrounding stones so that, when a wall becomes wet, the moisture within the stones can disperse and be drawn away from the surrounding stones and out of the mortar joints where it is driven off into the atmosphere.

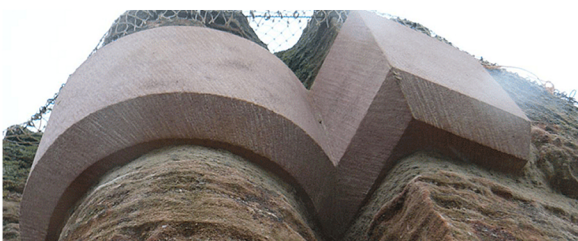
Lime mortar was used in the conservation of Lindisfarne Priory, an understanding of material science and local knowledge of available materials was the key to successful conservation at Lindisfarne Priory.
